UNITED STATES DISTRICT COURT  
FOR THE SOUTHERN DISTRICT OF OHIO  
EATERN DIVISION

XTO Energy, Inc.,

Civil Action No. 24-4269

**COMPLAINT**

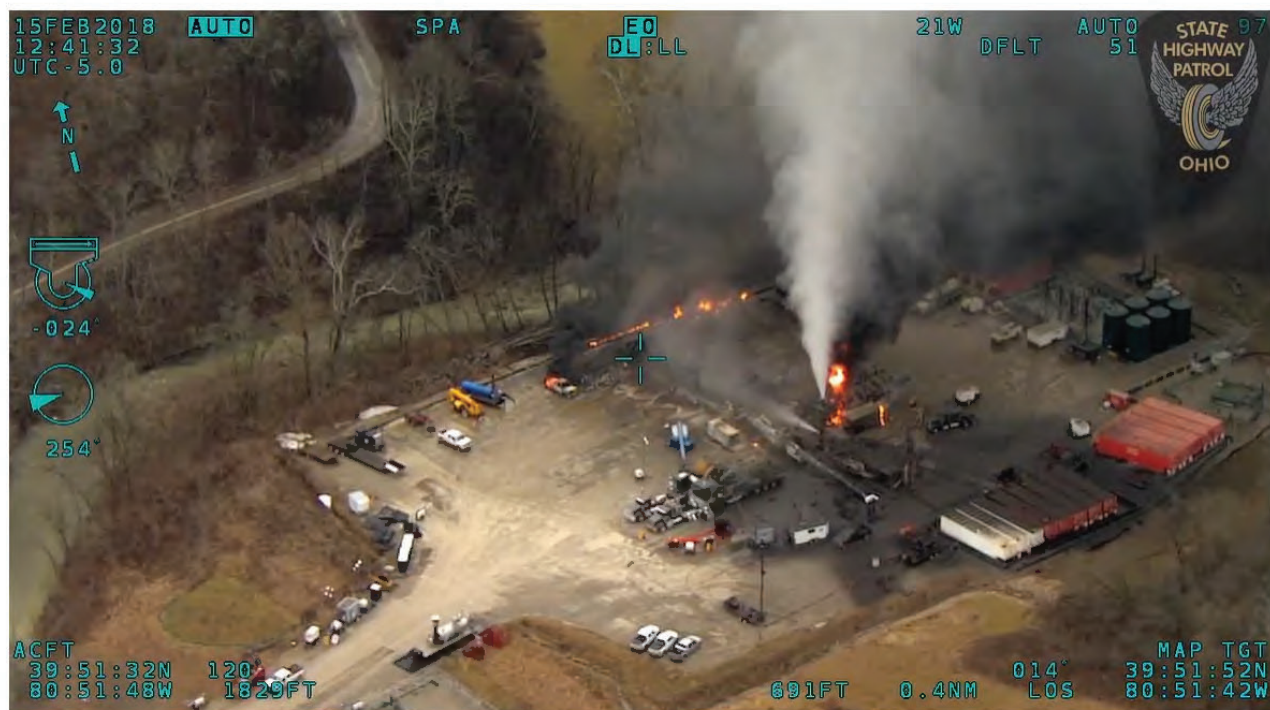
74. During post fracking coil drill-out operations, the 13 3/8" intermediate casing burst, causing the well to drop approximately one foot. The drop sheared off multiple valves, including the 2-inch flow cross.

75. Gravel and fracking fluids were blown across the Well Pad, and then the Schnegg C 7H well began venting uncontrolled gas.

76. The uncontrolled gas that vented from the Schnegg C 7H well contained, among other materials, methane (CH<sub>4</sub>).

77. The uncontrolled gas ignited, causing the crane holding the coil injector head to fall and contact the adjacent Schnegg B 9H well, damaging that well.

78. Below is a frame from a video of the ongoing release captured by Ohio's State Highway Patrol on February 15, 2018:
